## Memorandum

*Subject: Summary of Oversight of Physical Water Column Monitoring and Equipment Servicing  
July 29–August 1, 2019  
Lower Passaic River Restoration Project*

On behalf of the United States Environmental Protection Agency (EPA) and the United States Army Corps of Engineers (USACE), Kansas City District, CDM Federal Programs Corporation (CDM Smith) traveled to the Lower Passaic River Study Area (LPRSA) on Monday, July 29 through Thursday, August 1, 2019 and provided field technical oversight for the first round of surface water sampling and second round of mooring servicing associated with the Physical Water Column Monitoring (PWCM) program.

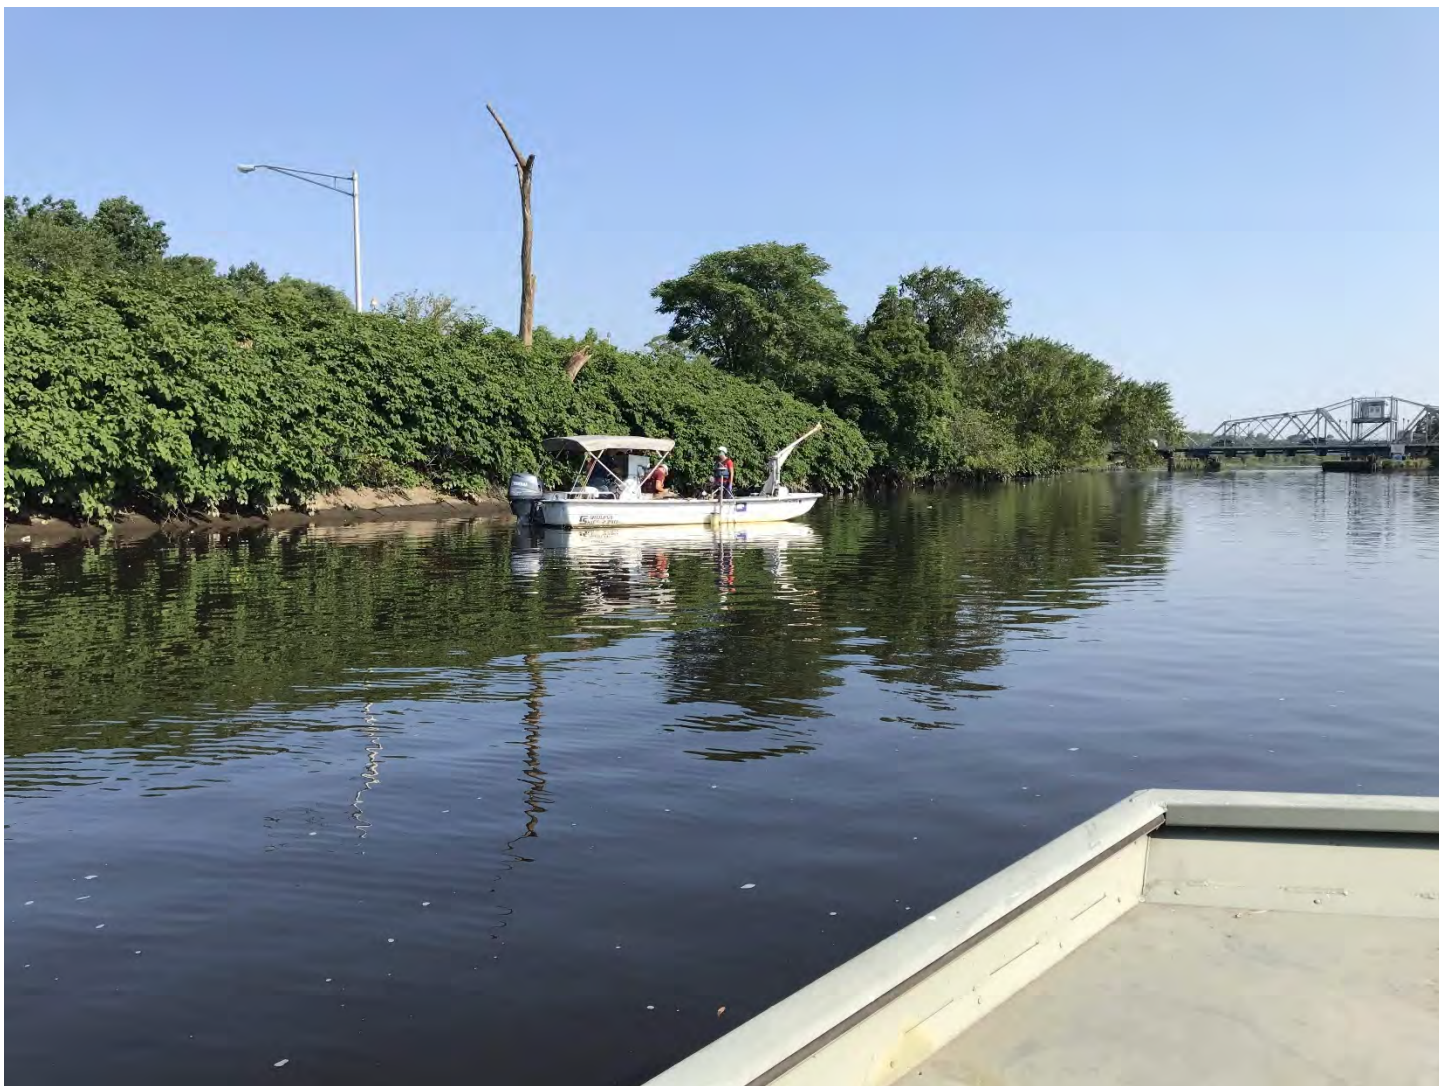
Photograph 1: Vertical YSI profile being performed at RM 10.2 during ebb tide.

All personnel mobilized to RM 10.2 to begin collecting surface water samples on the ebb tide. Seven locations (location 1 through location 7, from left to right across the river when facing upstream) were occupied for purposes of collecting water quality data or collecting water quality data and surface water samples for analysis. For the duration of the transect, flow data was obtained from a boat-mounted ADCP. Vertical YSI profiles were collected from all seven positions. Samples were collected from positions 2, 4, and 6 at two depth intervals (surface and bottom), in accordance with the approved CPG QAPP. For all sample locations, the bottom depth interval was sampled first, following a vertical YSI profile from surface to bottom. Sample containers were filled directly from the free-flowing outlet of the peristaltic pump.

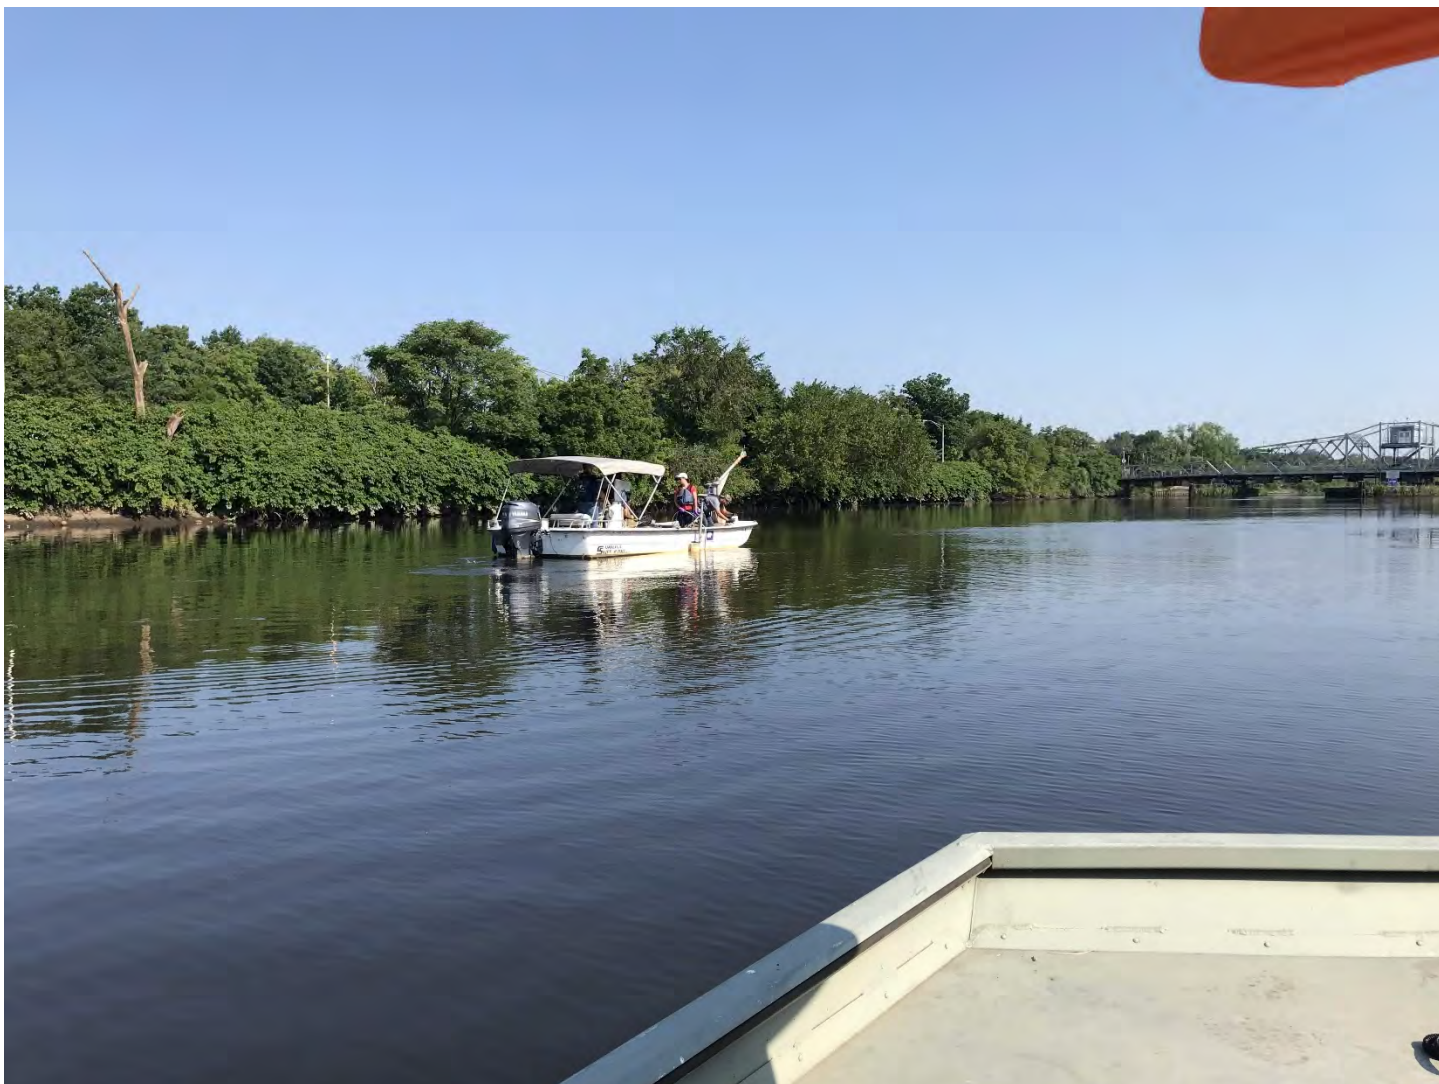
Photograph 2: Sampling being performed on RM 10.2 transect during ebb tide.

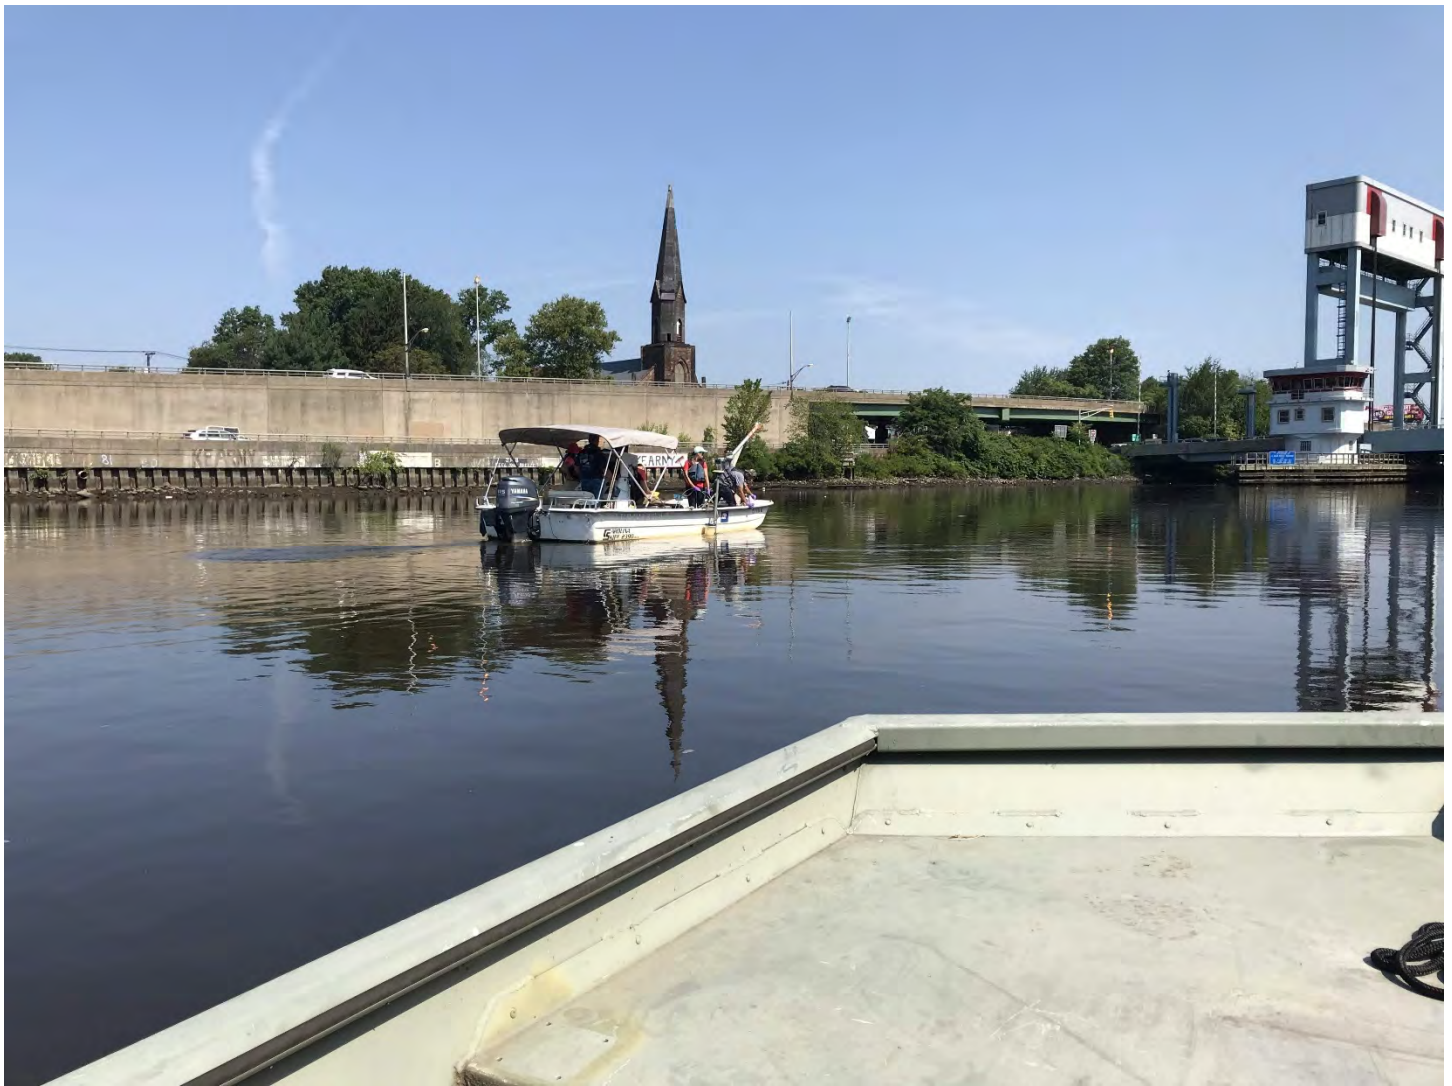
Photograph 3: Sampling being performed on RM 8.4 transect during ebb tide.

All personnel mobilized to RM 8.4 to begin collecting surface water samples on the ebb tide. Samples and YSI profiles were collected as described above. Kristen Durocher informed the crew that all RM 8.4 locations had been shifted because the locations, as marked in the CPG QAPP, extended out of the water and into the treeline. AECOM will provide final coordinates of all transect locations at the conclusion of PWCM.

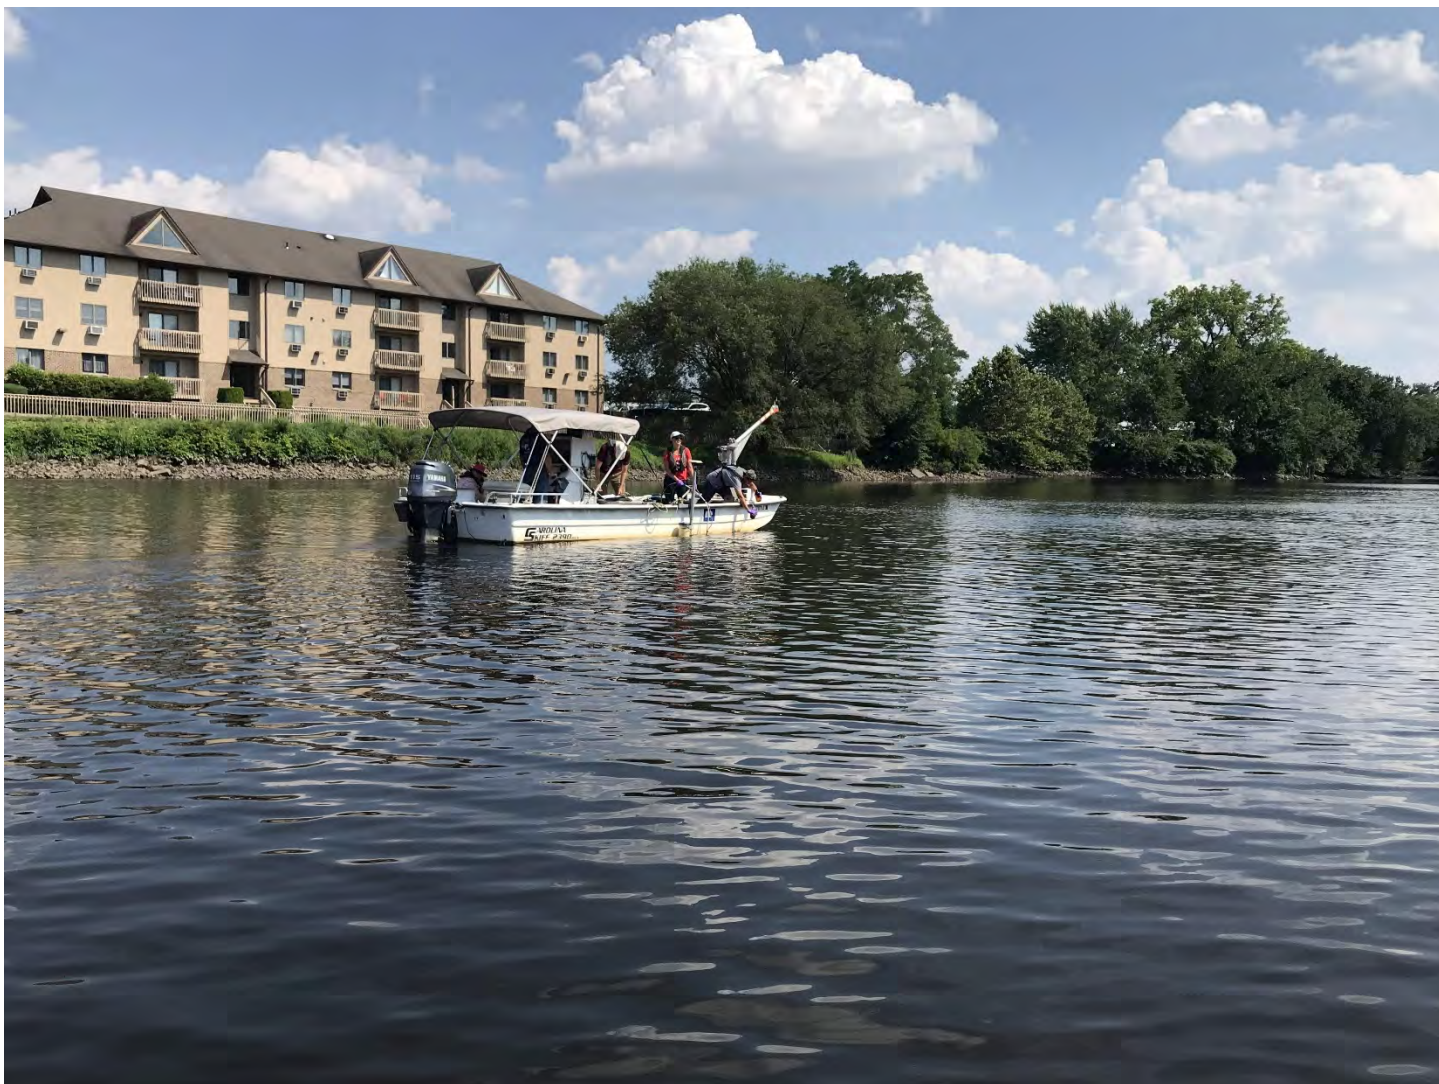
Photograph 4: Sampling being performed on RM 10.2 transect during flood tide.

When the tide shifted to flood, all personnel mobilized to RM 10.2 to collect surface water samples on the flood tide. Samples and YSI profiles were collected as described above. At 15:20, the 19C-CE02-T102-P4AS-CDM split sample was collected (from the top sampling depth at location 4 along the RM 10.2 transect). OSI dropped off Kristen Durocher at a nearby boat ramp.

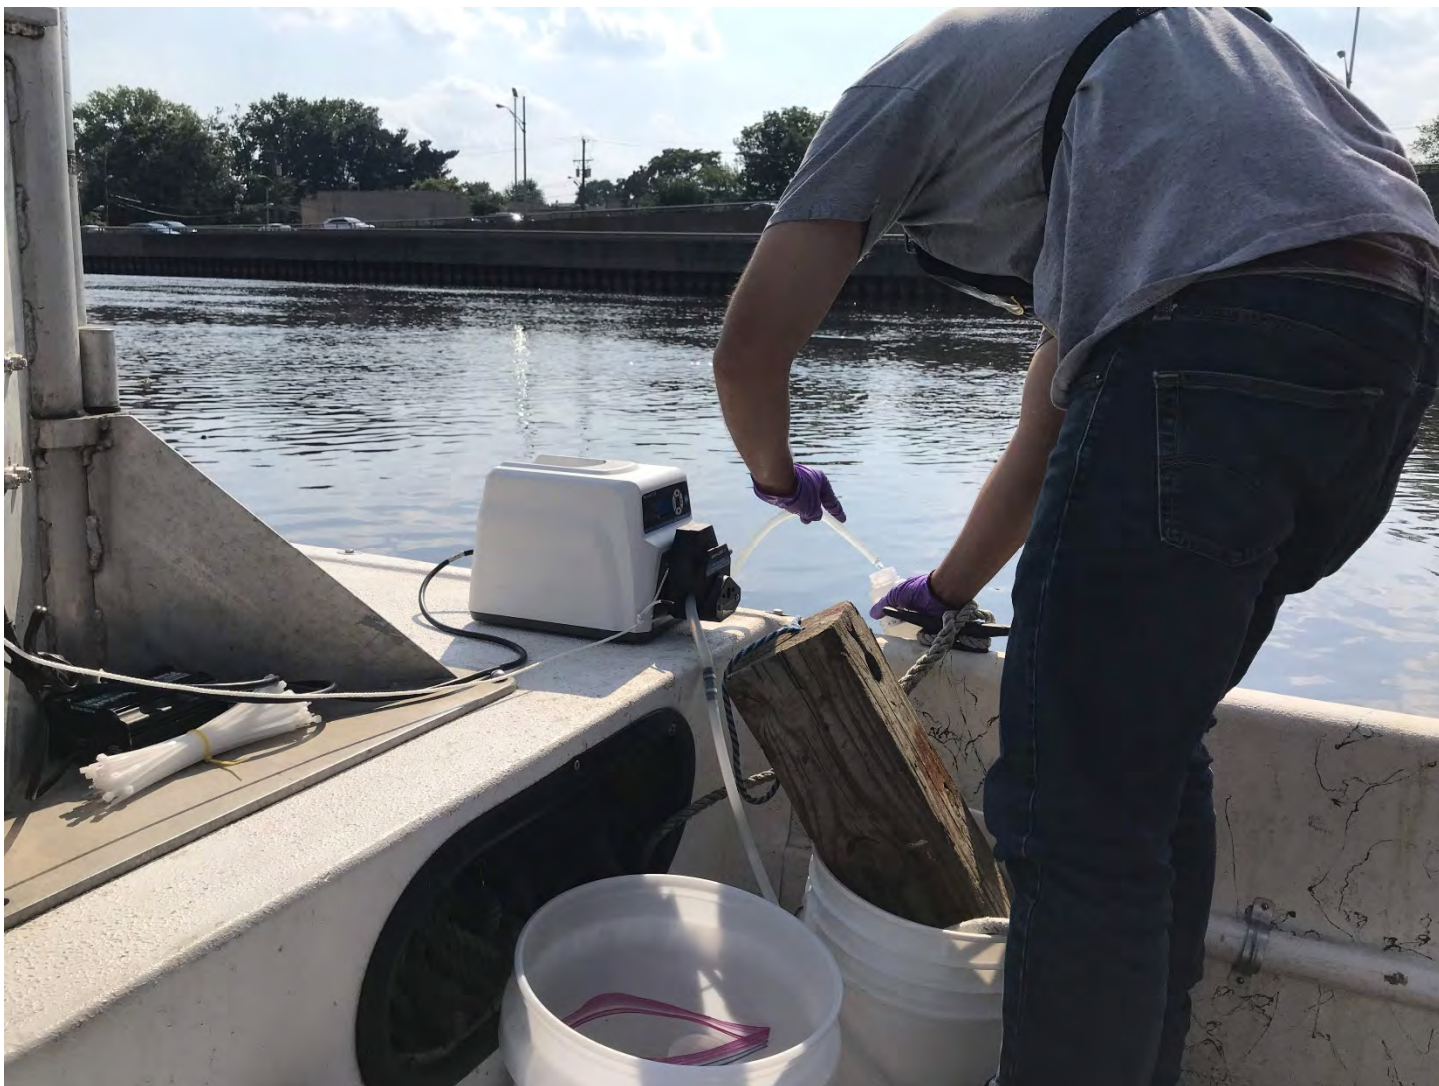
Photograph 5: Sampling being performed on RM 8.4 transect during flood tide.

All personnel mobilized to RM 8.4 to collect surface water samples on the flood tide. Since Kristen Durocher was no longer on OSI's boat, there was room for Alex Warzinski to come aboard. Samples and YSI profiles were collected as described above. At 16:13, the 19C-CE02-T084-P2BS-CDM split sample was collected (from the bottom sampling depth at location 2 along the RM 8.4 transect) and at 16:38, the 19C-CE02-T084-P6BS-CDM split sample was collected (from the bottom sampling depth at location 6 along the RM 8.4 transect).

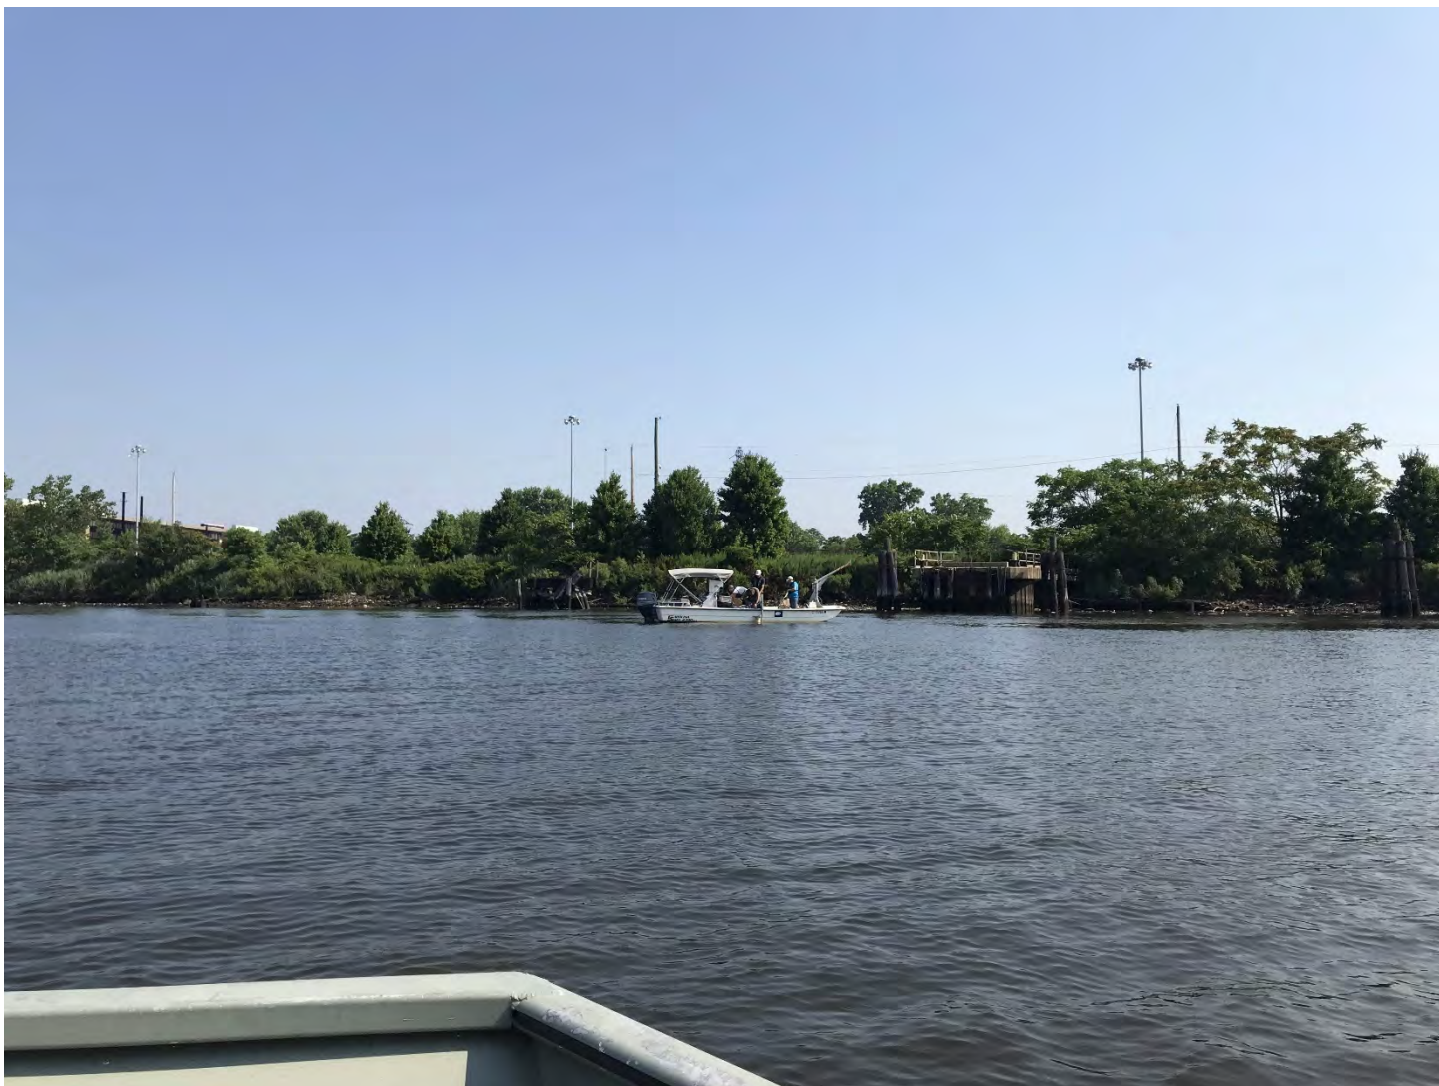
Photograph 6: Locating the salt front during ebb tide.

The 2 ppt salt front was located approximately at the bridge near the Red Bull Arena. Both boats mobilized 2 miles downstream to begin the longitudinal transect during the ebb tide. Sample collection and vertical YSI profiles were conducted, with the most downstream location labeled location 1. Samples and profiles were collected every quarter mile to 1 mile above the 2 ppt salt front in accordance with the CPG QAPP. At 09:58, the 19C-CE04-TSAL-P1AS-CDM split sample was collected (from the top sampling depth at location 1 along the longitudinal transect). At 10:10, the 19C-CE04-TSAL-P2BS-CDM split sample and 19C-CE04-TSAL-P2BS-CDM-100 duplicate split sample were collected (from the bottom sampling depth at location 2 along the longitudinal transect). At 10:58, the 19C-CE04-TSAL-P5AS-CDM split sample was collected (from the top sampling depth at location 5 along the longitudinal transect). At 11:55, the 19C-CE04-TSAL-P9BS-CDM split sample was collected (from the bottom sampling depth at location 9 along the longitudinal transect). Upon completion of the ebb tide

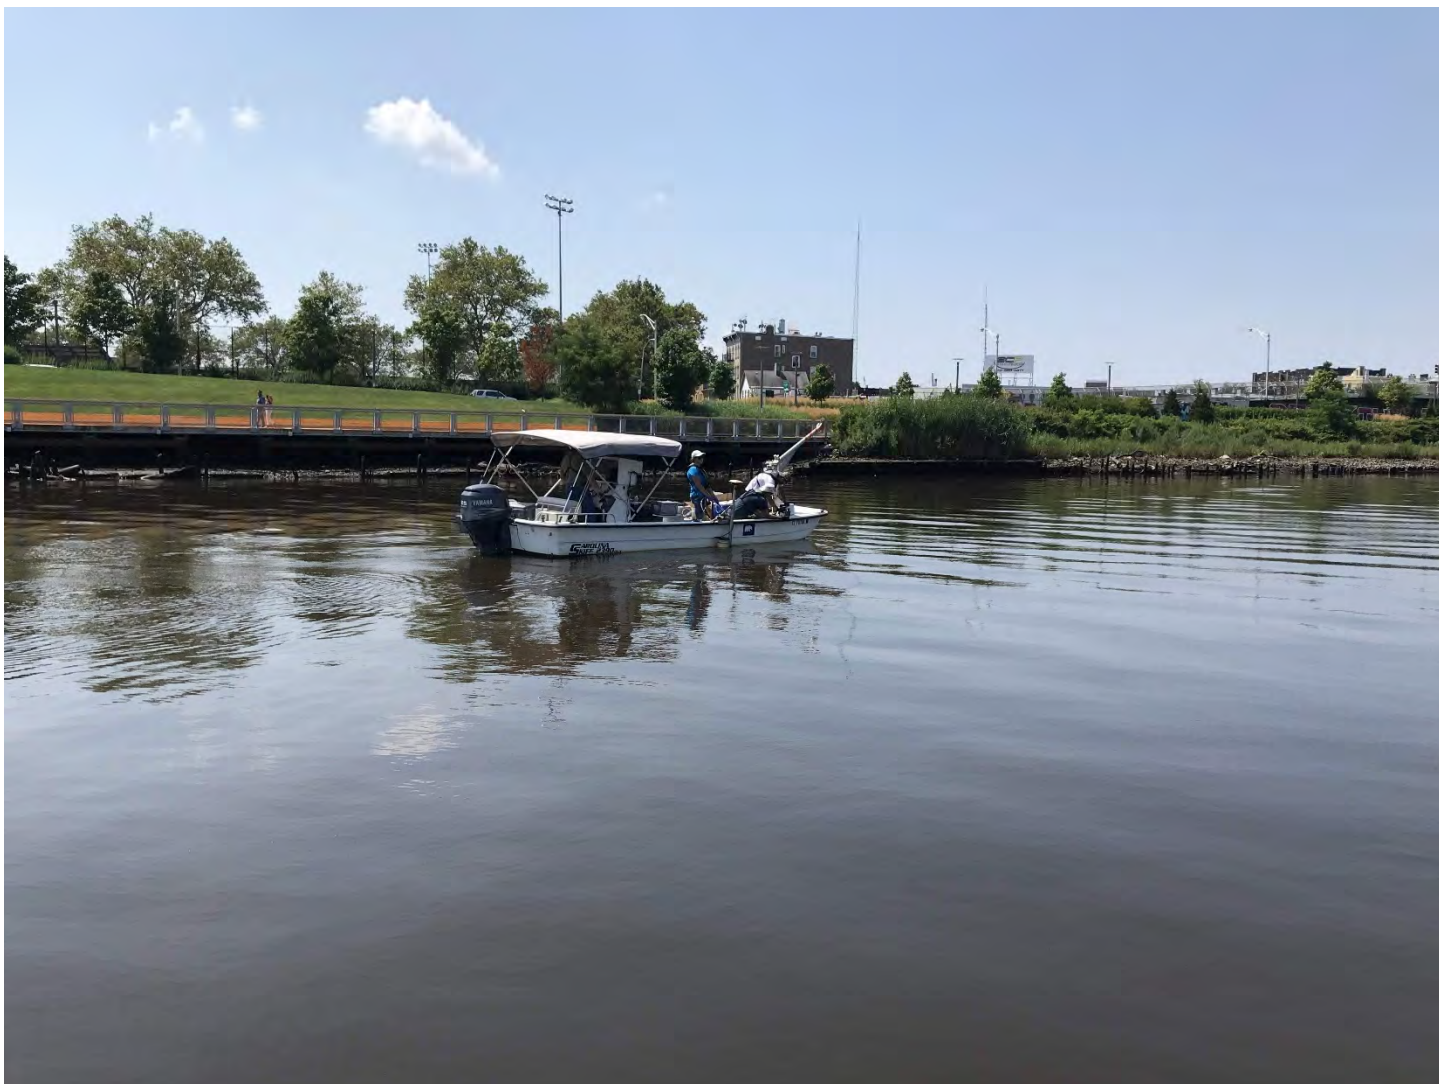
Photograph 7: Collecting split sample along longitudinal transect during ebb tide.

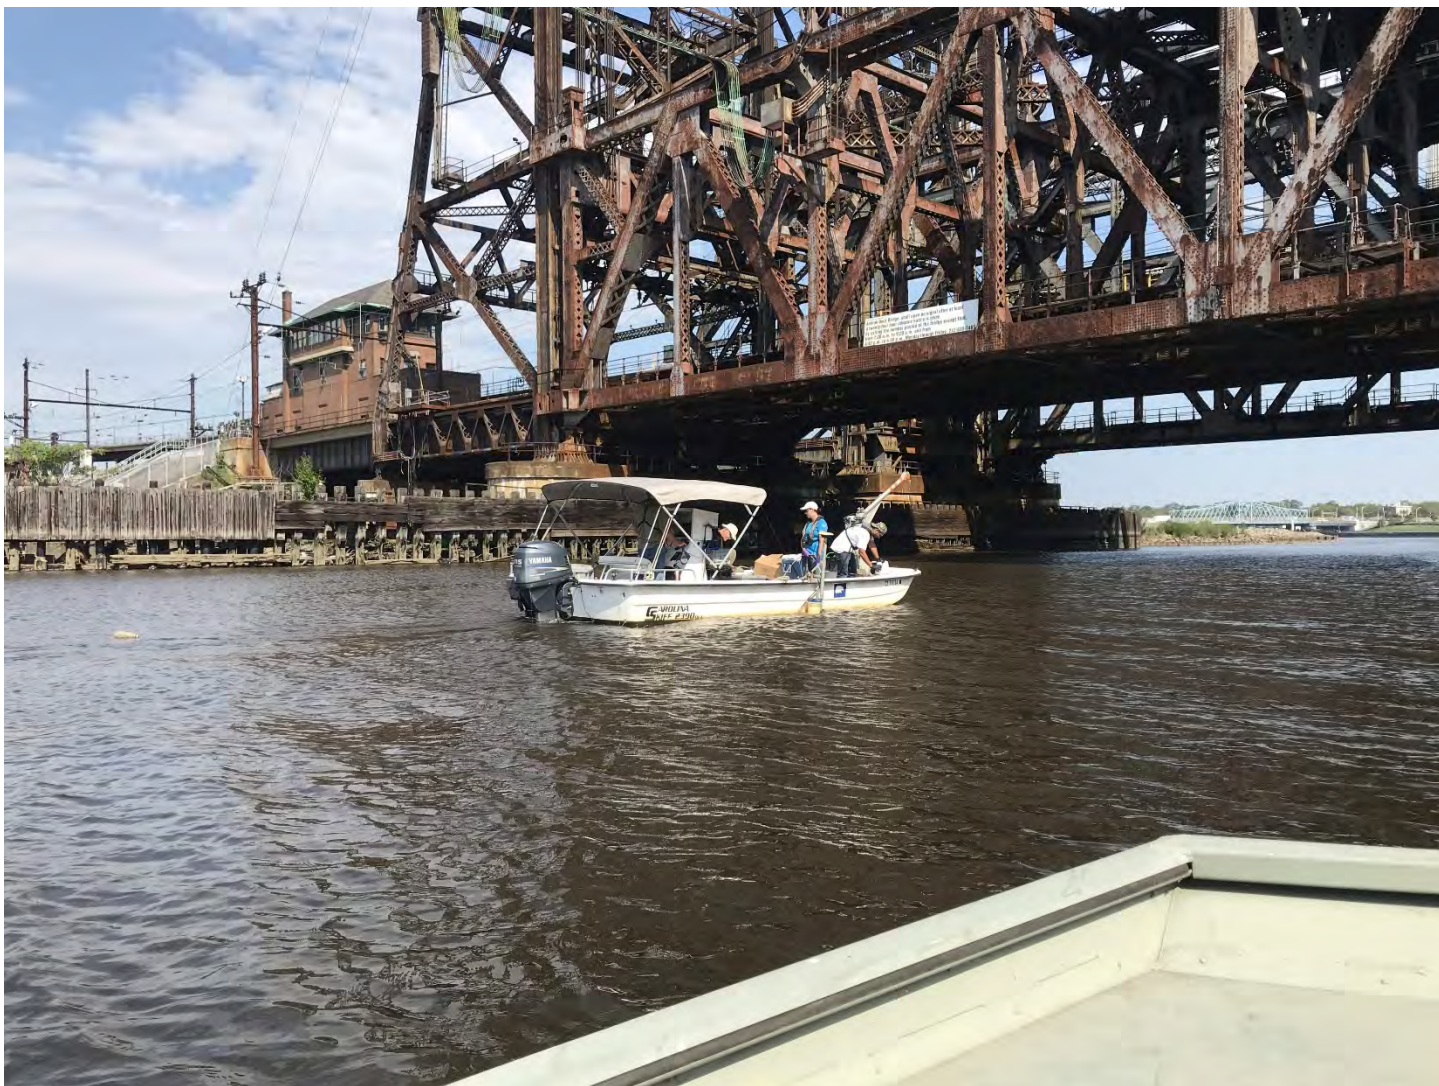
Photograph 8: Collecting sample along longitudinal transect during flood tide.

All personnel mobilized to relocate the 2 ppt salt front during flood tide. Due to the tide (and salt front) moving upriver during the flood tide, the flood tide longitudinal transect was collected from upstream to downstream. Location 1 was still identified as the most downstream location. The reverse sampling approach was discussed as being consistent with the goal of collecting peak turbidity data along the transect. The high turbidity near the salt front would be bracketed regardless of sampling directions, and sampling the opposite direction of salt front movement ensures that the salt front will be caught during sampling (the salt front moves at roughly the same rate the crew can purge and sample). At 16:48, the 19C-CE02-TSAL-P8BS-CDM split sample was collected (from the bottom sampling depth at location 8 along the longitudinal transect). At 17:49, the 19C-CE02-TSAL-P4AS-CDM split sample was collected (from the top sampling depth at location 4 along the longitudinal transect). Following collection of the flood tide longitudinal transect, all personnel mobilized back to the 1 Madison Road boat dock and secured the boats for the evening.

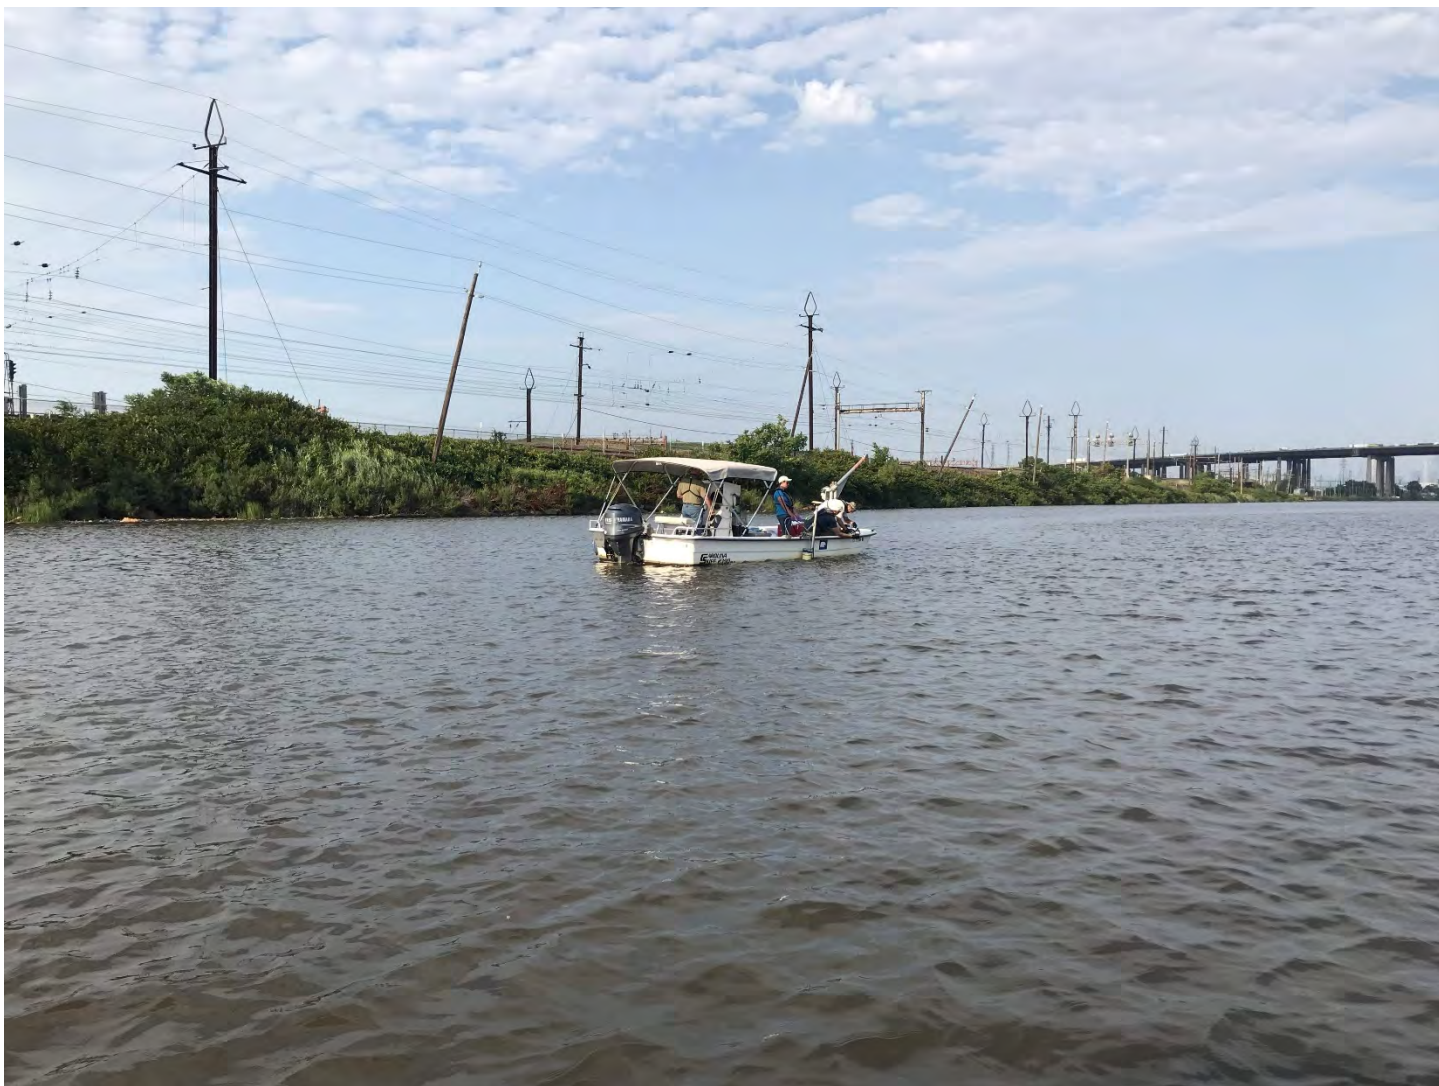
Photograph 9: Collecting split sample along longitudinal transect during flood tide.

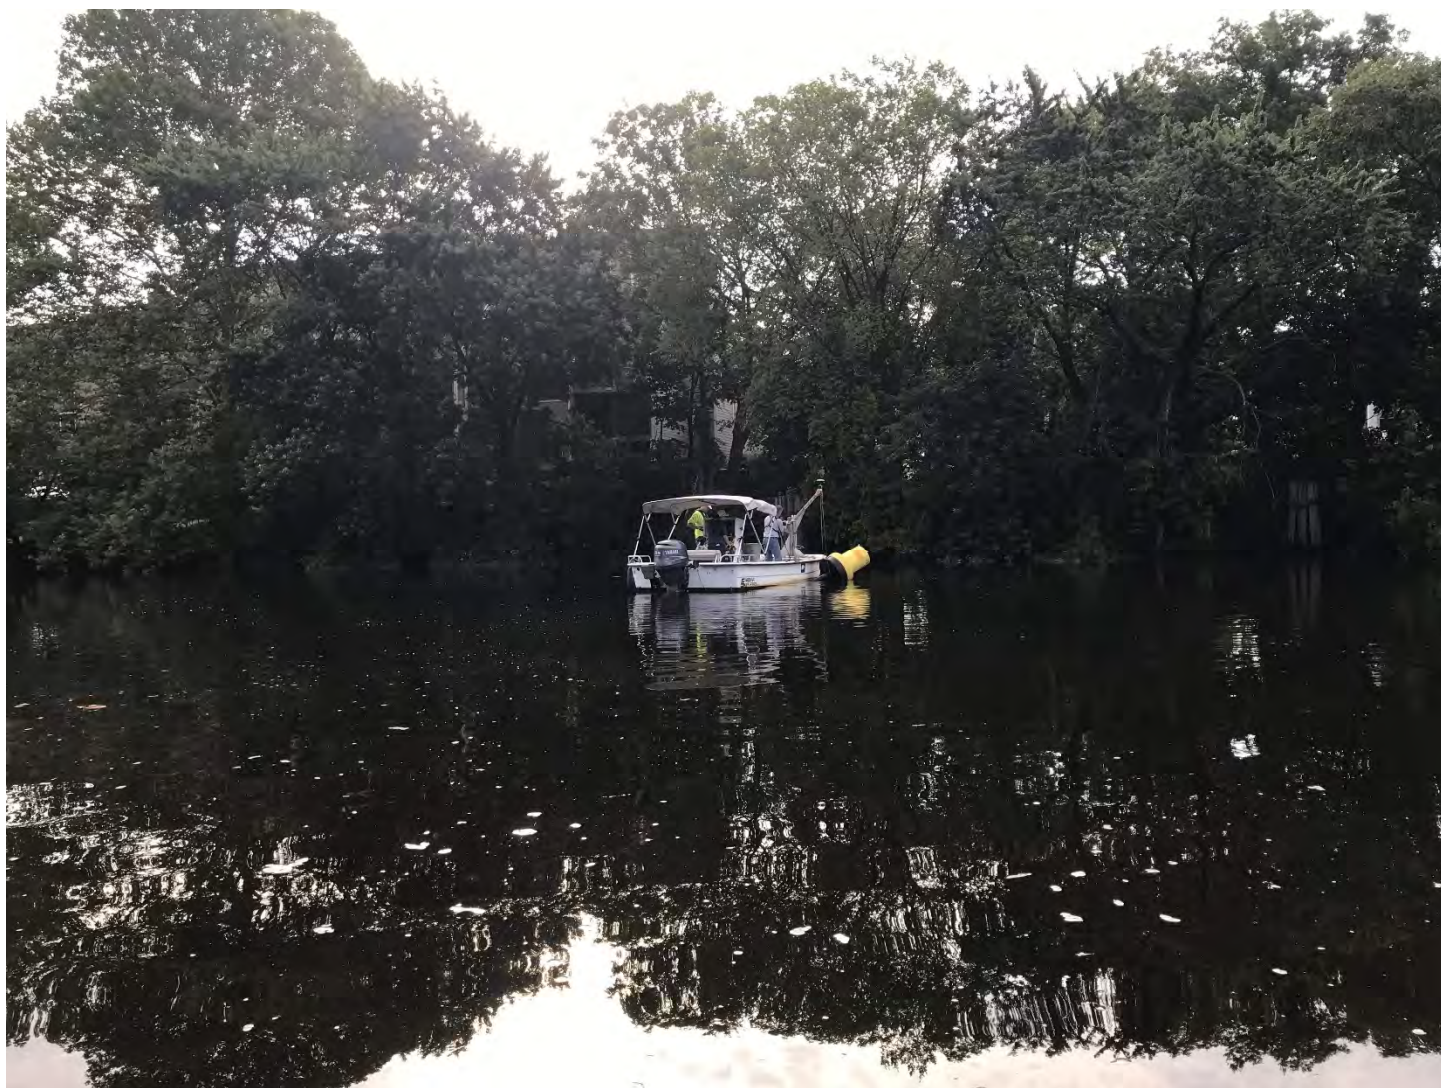
Photograph 10: Retrieving RM 13.5 buoy for servicing.

Both crews mobilized to RM 13.5. OSI began by collecting a vertical YSI profile at RM 13.5. OSI then began servicing the RM 13.5 buoy-mounted YSI. The YSI was removed and cleaned, had its data downloaded, had its wiper confirmed functional, and was compared against the calibrated boat YSI. The comparison was good (here and elsewhere in this oversight summary report, a good comparison means that measurements from the deployed YSI did not show obvious data quality issues relative to the calibrated boat YSI), so the YSI was redeployed.

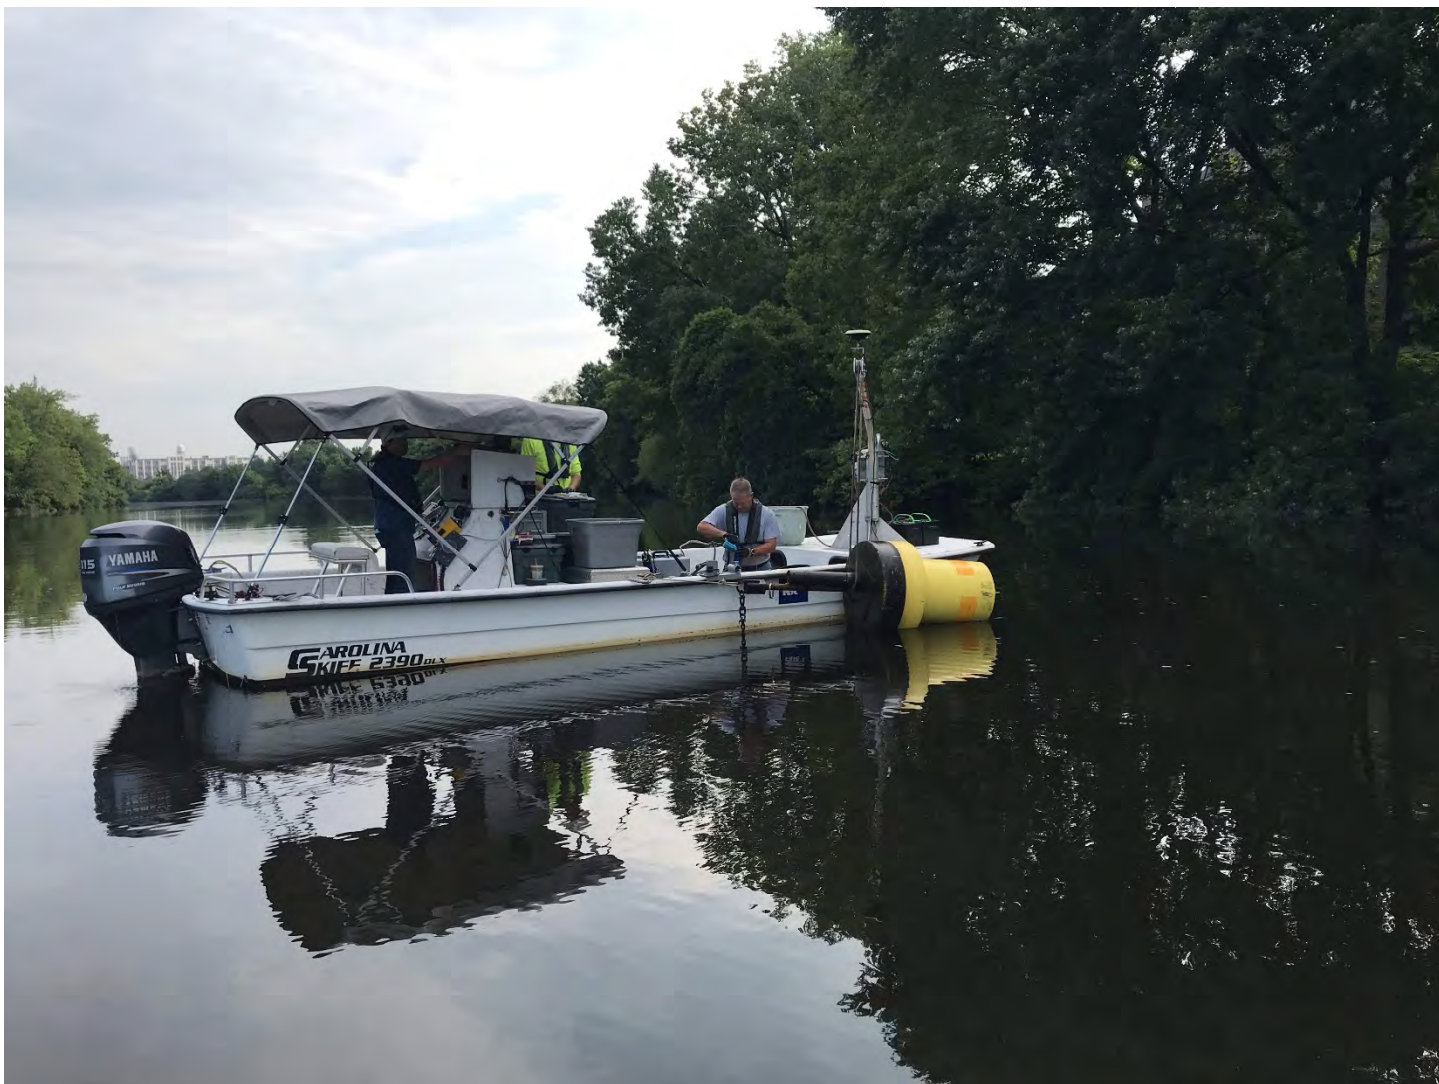
Photograph 11: Cleaning RM 13.5 top YSI sonde.

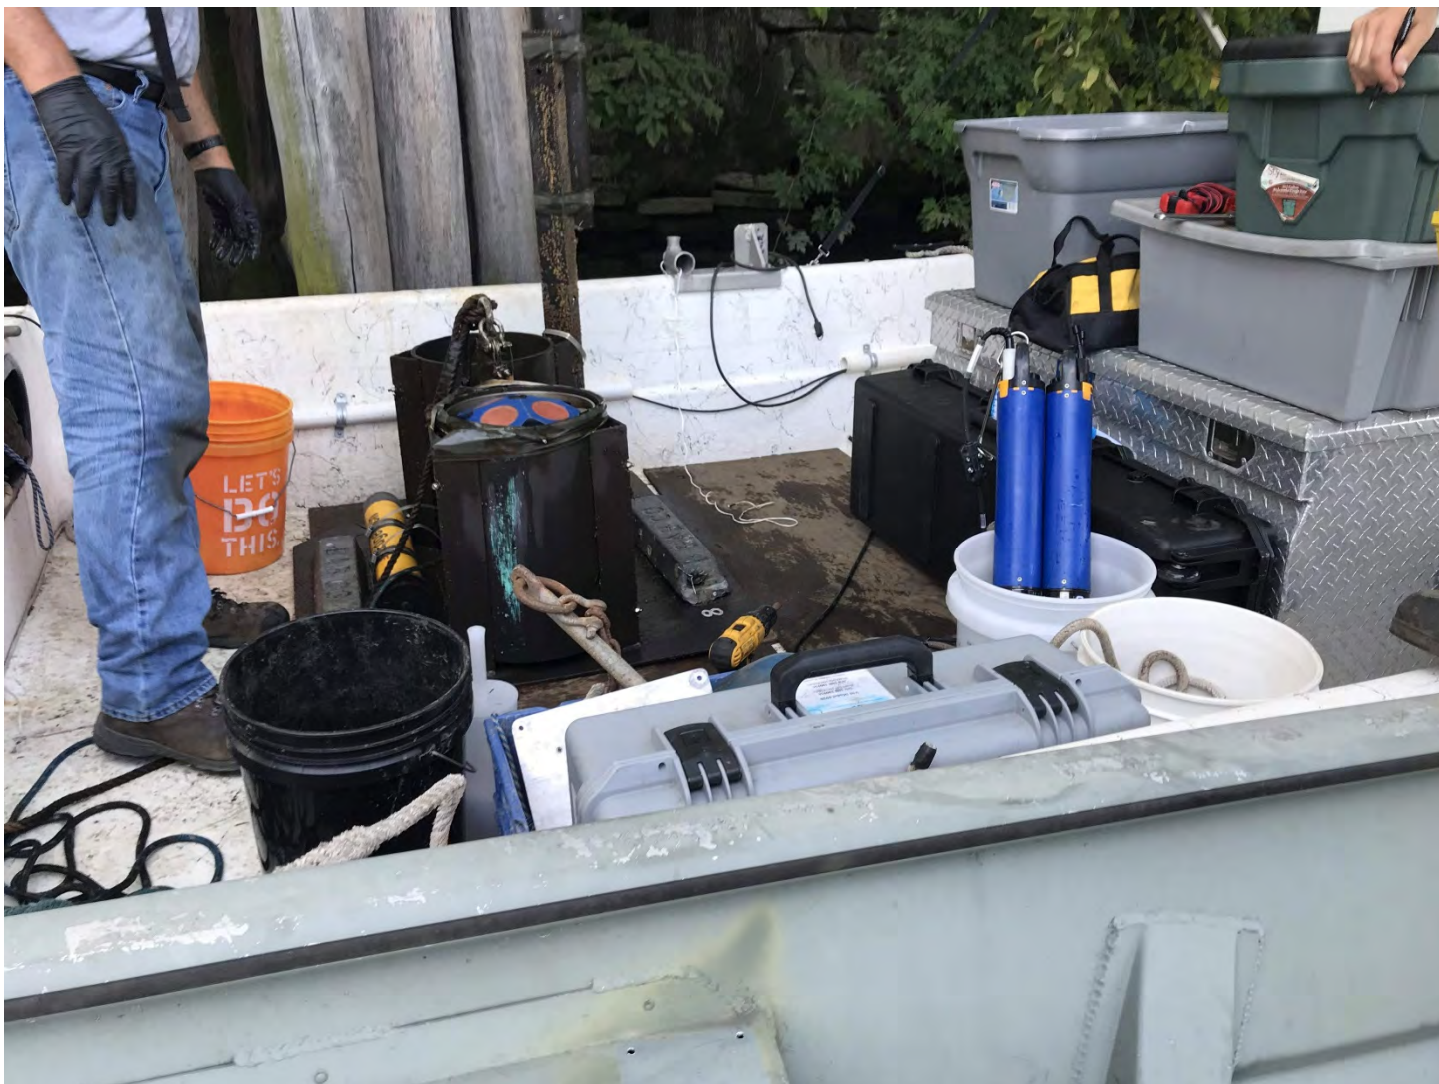
Photograph 12: Comparison of RM 13.5 bottom YSI sonde with calibrated boat YSI sonde.

The RM 13.5 bottom mooring locator buoy was released and the mooring was retrieved. The bottom-mounted YSI was removed and cleaned, had its data downloaded, had its wiper confirmed functional, and was compared against the calibrated boat YSI. The comparison was good. The ADCP was removed, cleaned, had its data downloaded, and its four sensors were confirmed to be functional. The ADCP battery was replaced and its compass was recalibrated. Both the ADCP and YSI were remounted, and the

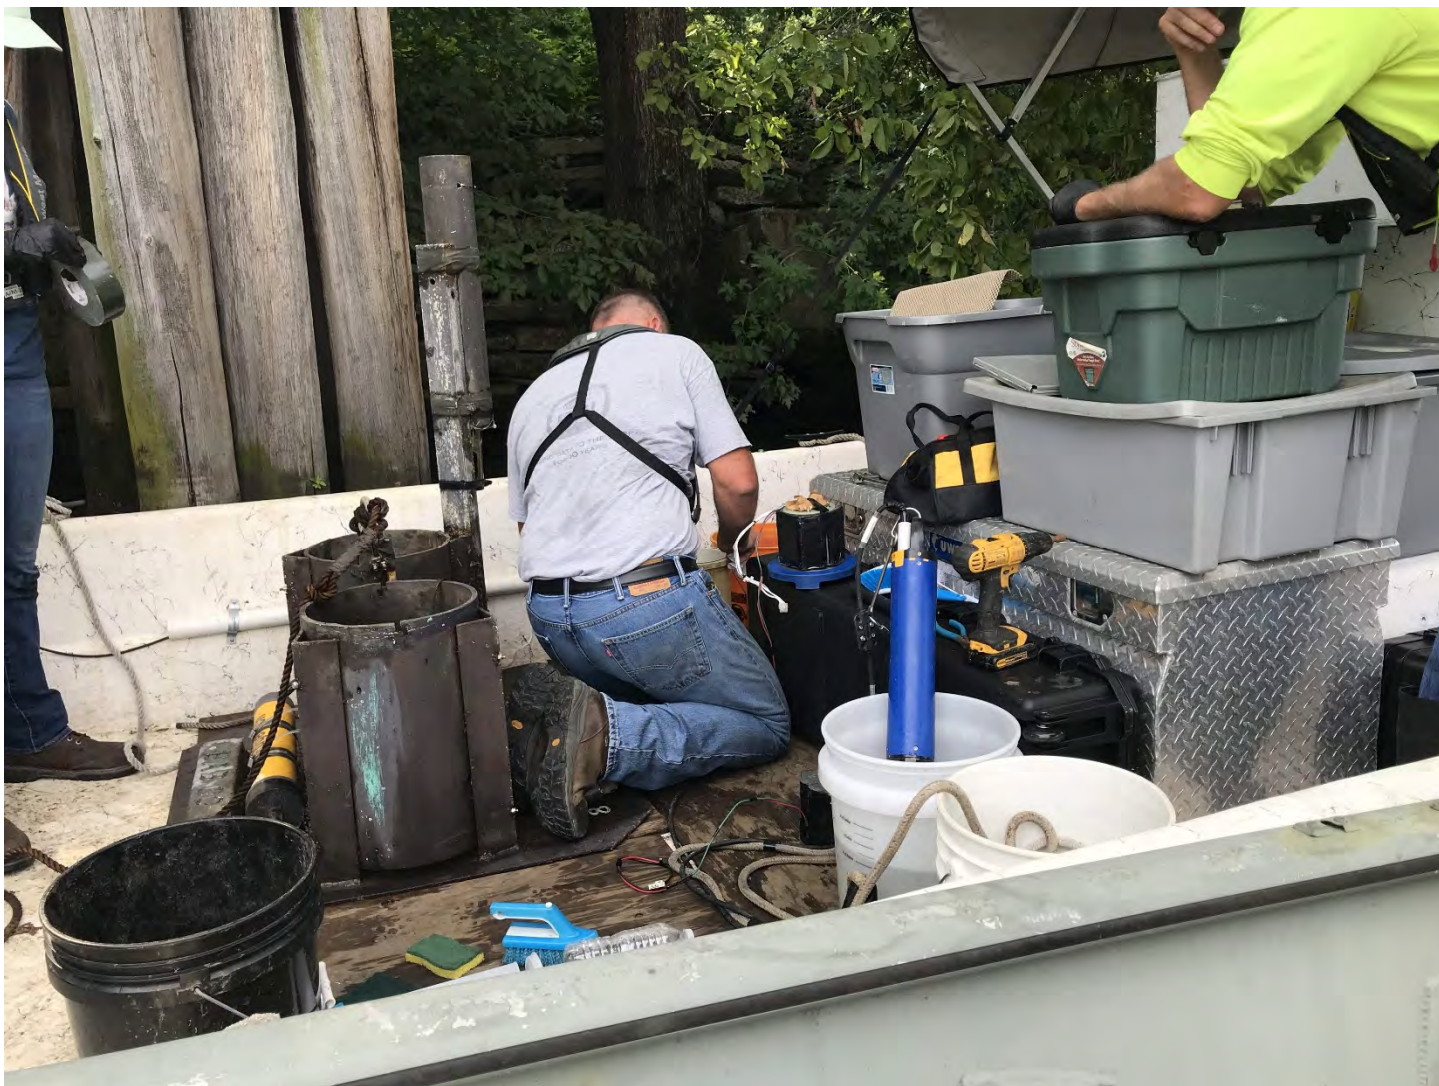
Photograph 13: Replacing RM 13.5 ADCP battery.
